Manhole Inspection Summary

Manhole # S63G__014MH

Location Address: **5100 Mason Lord Dr.**

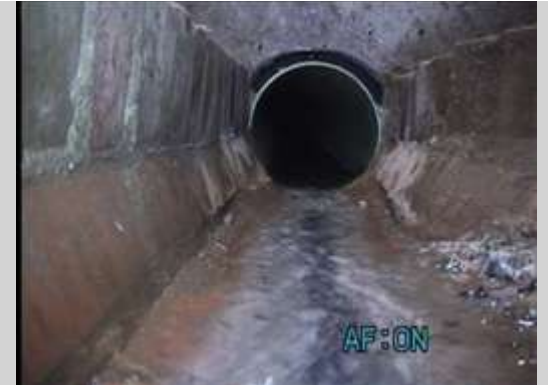
12 O'Clock Outflow

8 in. Circular Gravity Sewer
Pipe Out @ 12 O'Clock

Pipe Height: **8.4** (in.) Rod and Bar (Angled)
Pipe Material: **PVC** ☐ Pipe Lined
Invert Depth: **11.33** (ft.) Flow Characteristics: **Fast**
Deposits: ☒ None ☐ Mud ☐ Sludge ☐ Debris ☐ Grease
Silt Depth: (in.) Deposits Extent:
Infiltration: **None** Pipe Seal Cond: **Sound**

Drop: **None**
